## EXPERIMENTAL INVESTIGATIONS OF VIBRATIONS OF CENTRIFUGAL FIRE PUMP WITH THE DEFECT (UNFASTENED SHAFT IN A BEARING SEAT)

**Type of article:** case study – analysis of actual events

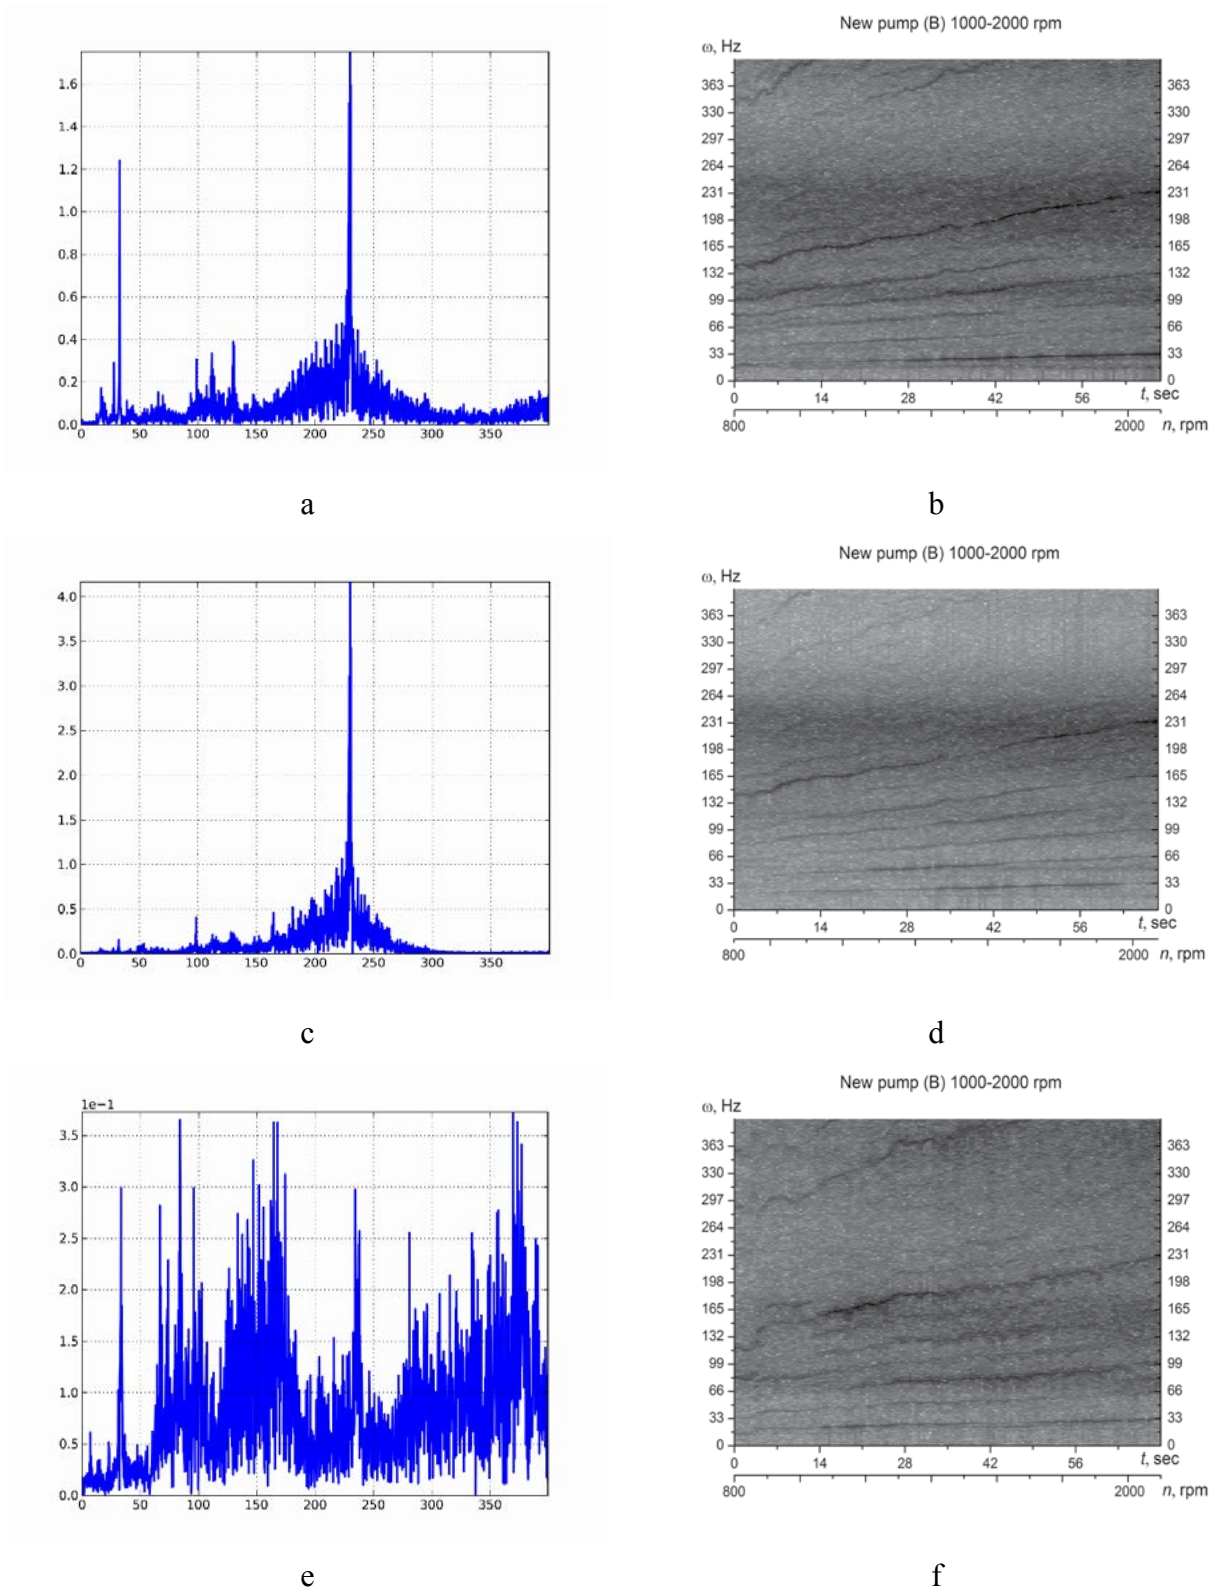
An analysis of vibrations at the frequency of excitation of 2000 rpm in the vertical direction which is presented on the Fig. 6,a shows a strong domination of 7 harmonic (233 Hz).

Besides it, in the spectrum exists first (33.3 Hz), third (99 Hz) and fourth (133 Hz) harmonics of rotor rotation. However, the most important phenomenon is in the pre-

sence of fraction harmonics in the spectrum, which indicates the presence of system nonlinearities caused by the presence of looseness and contact impacts. These harmonics are 0.5 and 3.5 harmonics of rotor rotation (16.5 Hz and 116.6 Hz).

The same result can be seen on the spectrogram, which is shown in Fig. 6,b. The analysis of presented measurements indicates a significant domination of the 1st (main) and 7th harmonics of rotor rotation.

Besides, the presence in the spectrum of fractional harmonics is also confirmed. The harmonic of the 0.5 of rotor rotation is observed in the all range of frequency of excitation. The harmonic with frequency 3.5 of rotor rotation appears only at high levels of vibration that is at the highest frequencies of excitation.

Analysis of spectrum and spectrogram for vibrations in the axial direction are close to the corresponding spectrum and spectrogram of non-defected fire pump vibrations at the appropriate regime. The harmonic with the

A quantitative comparison shows that the largest vibration level is observed in the axial direction and the smallest one is in the horizontal direction. A comparison of vibrations of the defected and non-defected fire pump showed that defect makes the axial direction weaker and this leads to increasing axial vibration acceleration up to 80%. Vibrations in other directions are approximately at the same level when it comes to defected and non-defected pumps.

**Fig. 6.** Spectrums (a, c, e) and spectrograms (b, d, f) of vibration accelerations of the fire pump, which has defect (unfasten shaft) in the vertical (a, b), the axial (c, d) and horizontal (e, f) directions

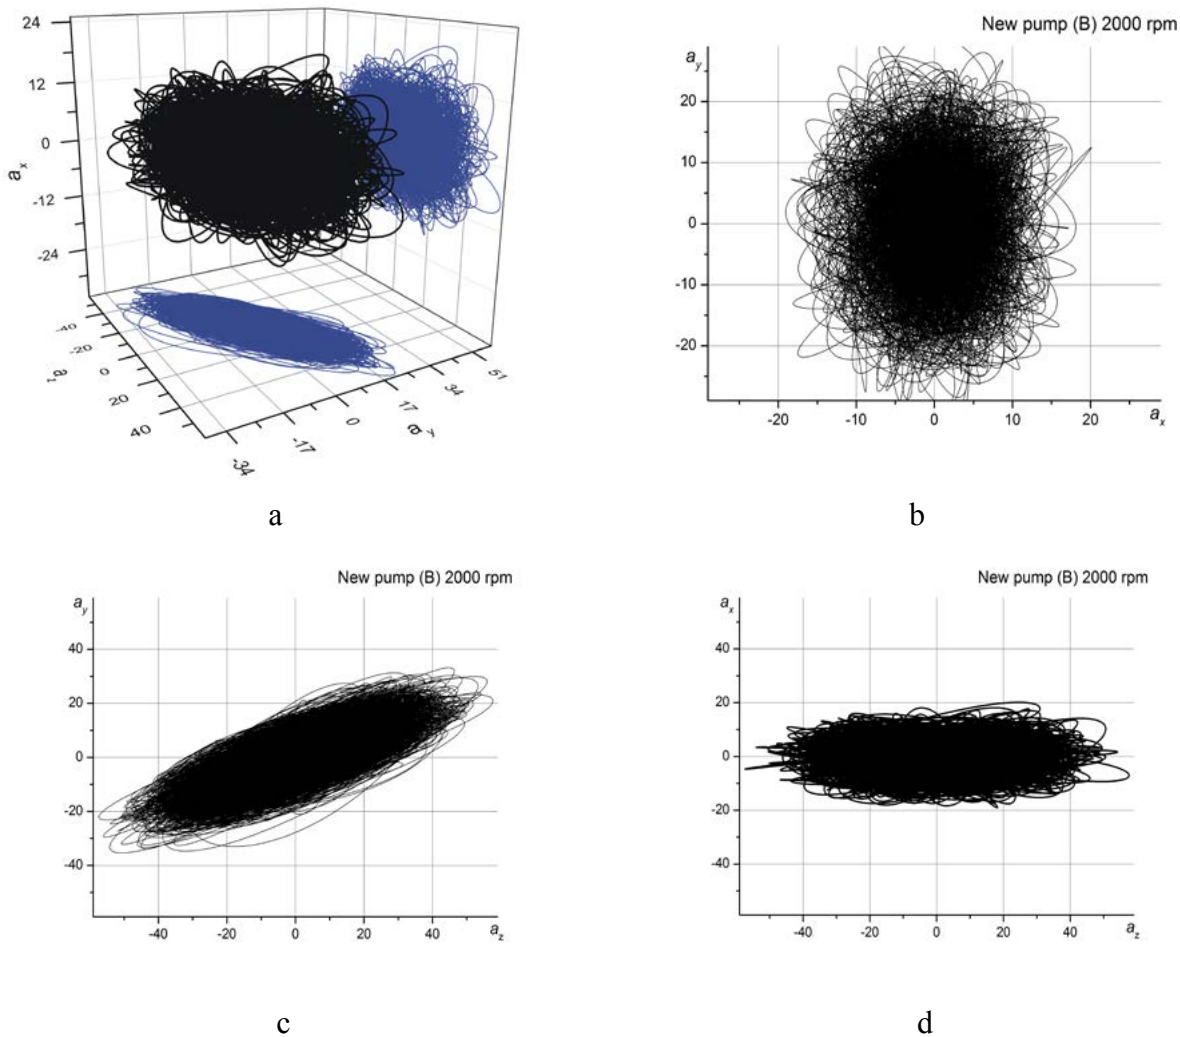
Fig. 7 shows the spatial trajectory of the acceleration vector at the point of the pump with the presence of internal defect. Apart from previously marked domination of the vibration in the axial direction, the phenomenon of changing of the angle of orientation of the ellipse tra-

jectory in the YZ projection are presented. Thus, the angle of the inclination of major axis of ellipse to the axial direction is around 80° that significantly differs from the previously obtained value of 55° for the non-defected fire pump.

**Fig. 7.** Spatial trajectory of vibrations acceleration vector of the fire pump, which has defect (unfasten shaft) (pump rotor angular velocity is about 2000 rpm) - the trajectory in space, (b, c, d) - its XY; YZ; XZ projections
