## EXPERIMENTAL INVESTIGATIONS OF VIBRATIONS OF CENTRIFUGAL FIRE PUMP WITH THE DEFECT (UNFASTENED SHAFT IN A BEARING SEAT)

**Type of article:** case study – analysis of actual events

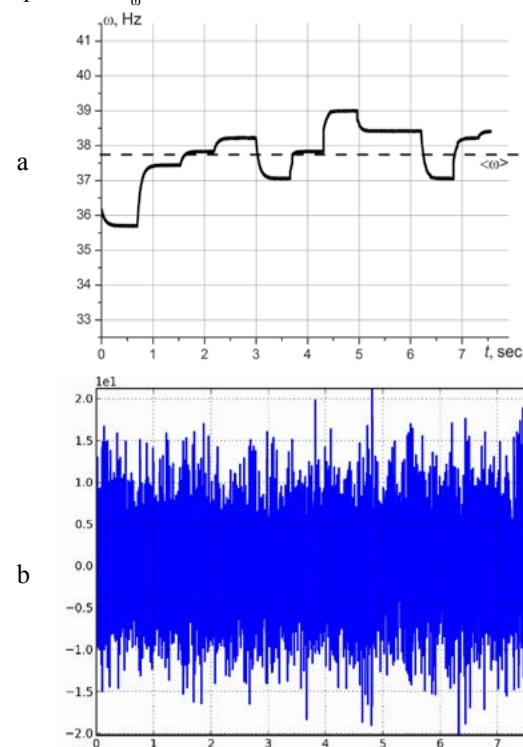
Fig. 2,a shows a typical realisation of time depending changing of the rotor angular velocity during the test. Average frequency was  $\langle \omega \rangle = 37.73$  Hz that corresponds to 2264 rpm. Variations in the frequency was observed in the range from 35.67 Hz to 39 Hz (2140 rpm - 2340 rpm) with dispersion  $\sigma_{\omega}^2 = 0.71$  Hz<sup>2</sup>.

Fig. 2. A typical obtained signals during the tests of fire pump vibration a – time varying angular velocity; b – recorded vibration acceleration signal

Fig. 2b presents vibrational acceleration obtained in the vertical direction at the measurement point. A presence of the random fluctuations and polyharmonic nature in the signal can be observed. At the same time, the signal has no outliers, periodic impacts or other evident signal distortions. This confirms the absence of the defects in the pump and its well performed assembling. Analogous tests with the over values of pump rotor angular velocities have been carried out to obtain more detailed information about the vibrational processes. Generalization of these results can be obtained by special tests, when vibrational signal is analyzed during continuous gradual increasing of the frequency of excitation. So, the test was made with the pump that operates with the angular velocity, which is gradually increased from 800 rpm to 2100 rpm.

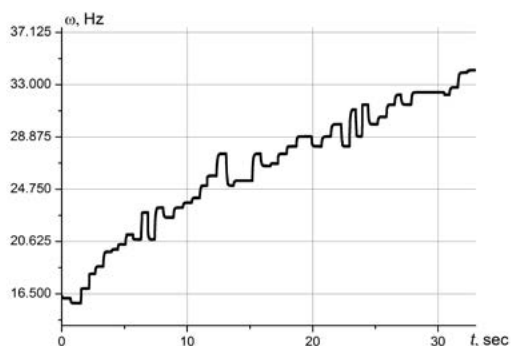
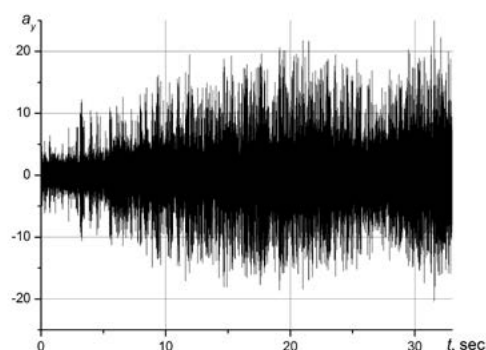
The obtained signals show dependence on time of angular velocity of the pump rotor (Fig. 3,a), and vibrational acceleration (Fig. 3,b). The test was held for 30 seconds.

**Fig. 3.** The test of the pump vibration with the continuous gradual increasing of the frequency of excitation  
a – registered signal from the frequency counter (rotor angular velocity in time);  
b – registered vibration acceleration signal in the vertical direction

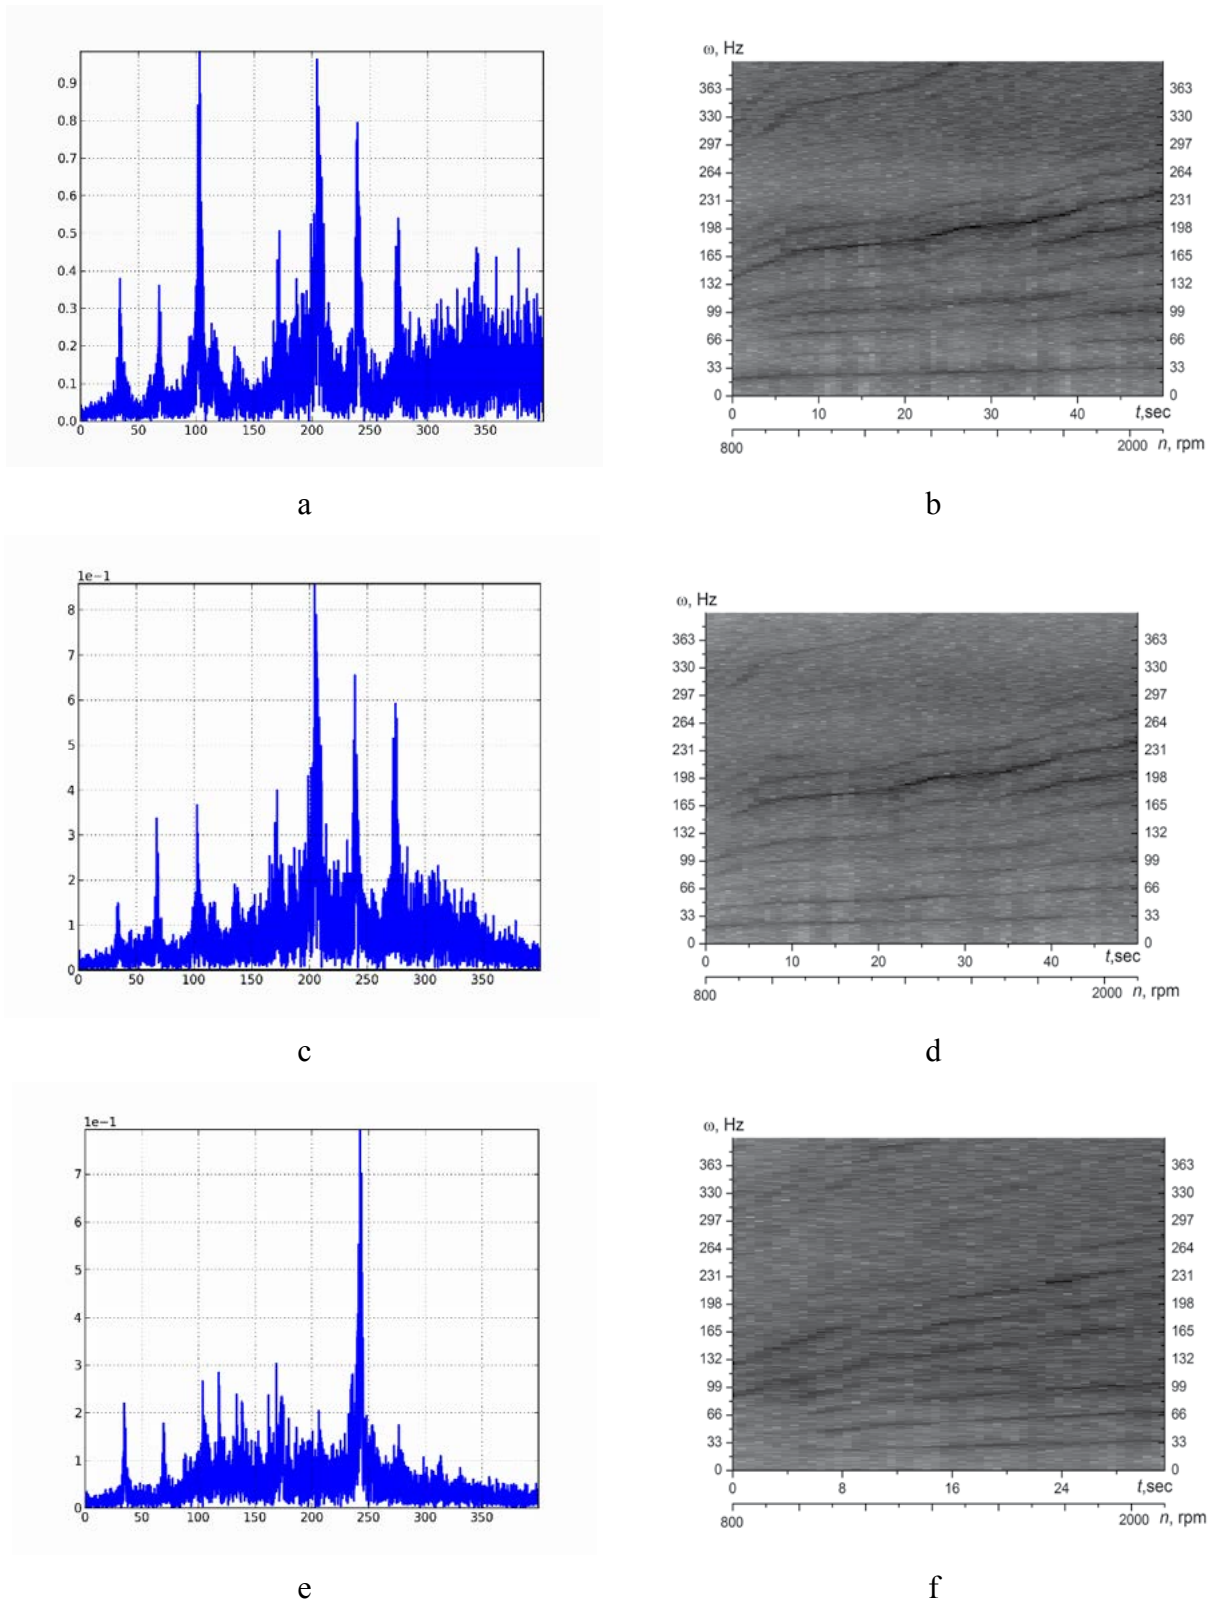
Fig. 4 presents vibration spectra at the fixed value of the pump rotor angular velocity (2000 rpm) and spectrograms for the vibration accelerations in three different directions. It should be noted that high harmonics have essential amplitudes in the spectrums of pump vibrations that even exceeded first based harmonic. It has become apparent especially for the 7 harmonic. This harmonic dominates all others in spectrums across the range of frequency of perturbation, especially for vertical and axial directions.

A quantitative comparison shows that the largest vibration level is observed in the vertical direction and the smallest one is observed in the horizontal direction.

**Fig. 4.** Spectrums (a, c, e) and spectrograms (b, d, f) of vibration accelerations of the fire pump in the vertical (a, b), the axial (c, d) and horizontal (e, f) directions

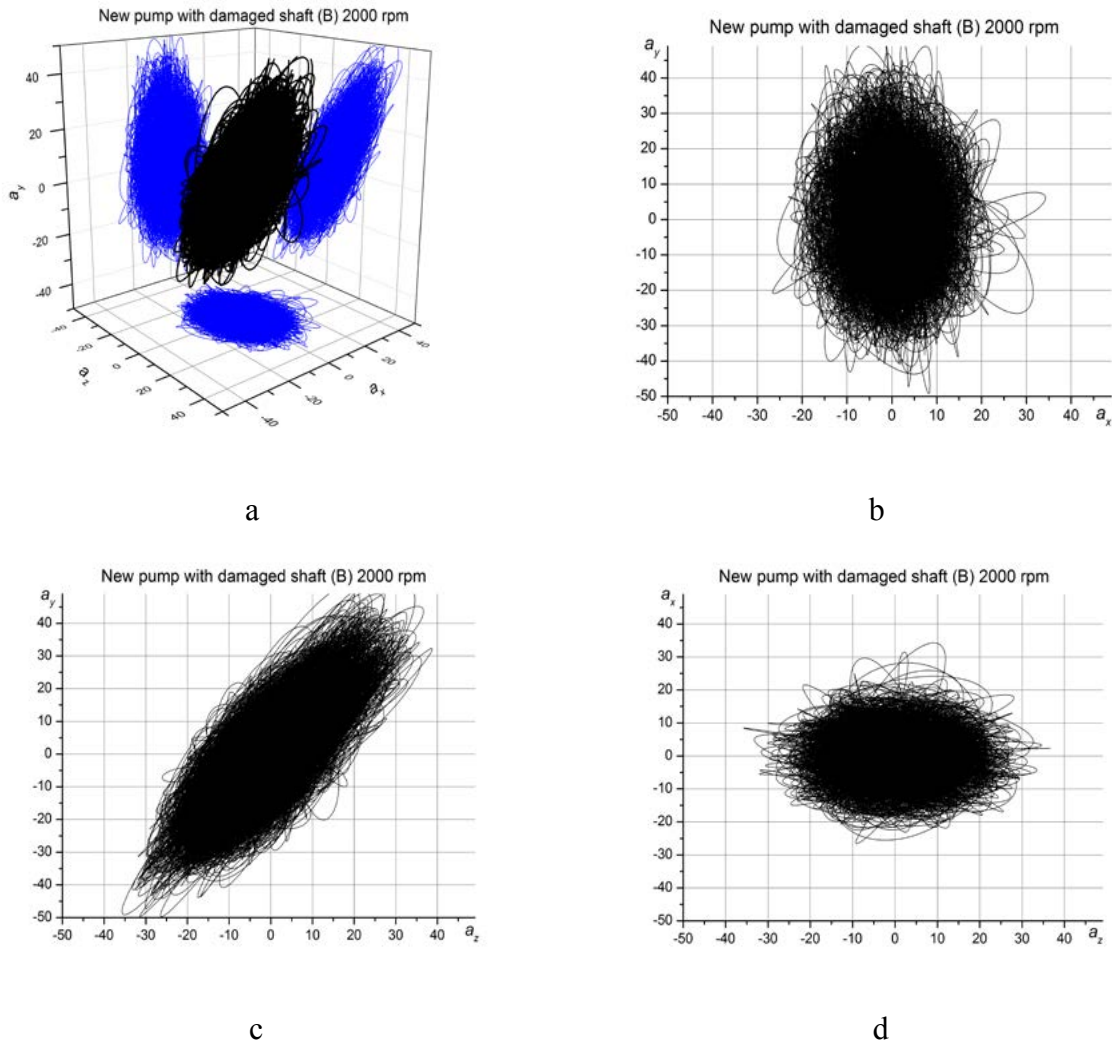
A detailed analysis of the orientation of vibration at the point of the pump can be made from the spatial trajectory of the acceleration vector. Corresponding results are shown in the Fig. 5.

**Fig. 5.** Spatial trajectory of vibration acceleration vector (pump rotor angular velocity is about 2000 rpm)  
 (a) - the trajectory in space, (b, c, d) - its XY; YZ; XZ projections
